Superdome Partial Power Outage

Report prepared for:
Entergy New Orleans, Inc.
SMG
Louisiana Stadium and Exposition District

By:
John A. Palmer, Ph.D., P.E., C.F.E.I.
3/21/2013

Report: February 3, 2013 Partial Power Outage at Superdome

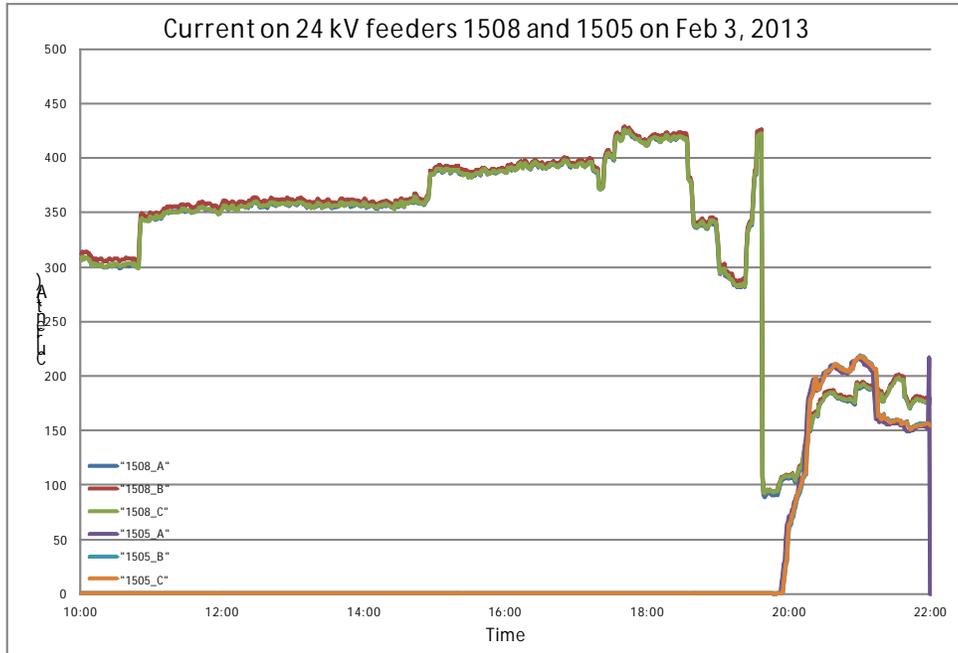
INCIDENT DESCRIPTION. During the Super Bowl, current through the feeders 1508 and 1505 was monitored at the 24 kV level with data recorded every minute. This data is charted in Figure 1.⁷ In addition, current was reportedly measured from time to time by Stadium personnel for their two 13.8 kV feeders. This data is illustrated in Figure 4.⁸ Both data sources indicate that after a temporary reduction in load from approximately 7:00-7:30 corresponding to the extinguishment of the lights during the half-time show, load increased substantially. The load rose quickly, as expected, peaking on the west feeder at a little less than 400 A before the relay in Bay 8 misoperated (tripped), causing the switch to open, deenergizing the west feeder. The current on the East feeder was never measured to be as high as the current in the West feeder.

Figure 1: Plot of current in the 24 kV Entergy feeders supplying power to the Superdome. Partial loss of power occurred at 7:37 p.m.

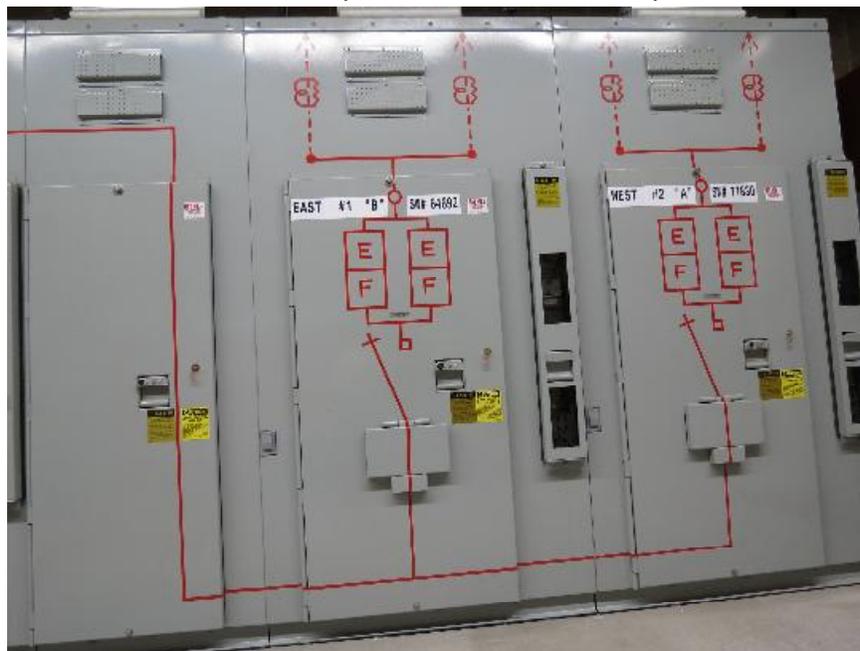
Power is normally delivered from the common bus in Vault 24 to the customer (the Superdome) through two feeders tied into Bay 7 and Bay 8 of the switchgear lineup (see Figure 2). The Bay 7 feeder was identified as the East feeder to the Superdome and the Bay 8 feeder was identified as the West feeder. Each stadium feeder was connected through a motorized load interrupter switch and a set of fuses. The switch in each bay was connected to an S&C ZSD relay so that the ZSD relay could initiate opening of the respective switch. During the Super Bowl, the Bay 8 switch opened, resulting in a loss of power to the West feeder and thence to the west side of the Superdome.

Figure 2: Bay 7 (center) and Bay 8 (right) of the Vault 24 switchgear lineup.

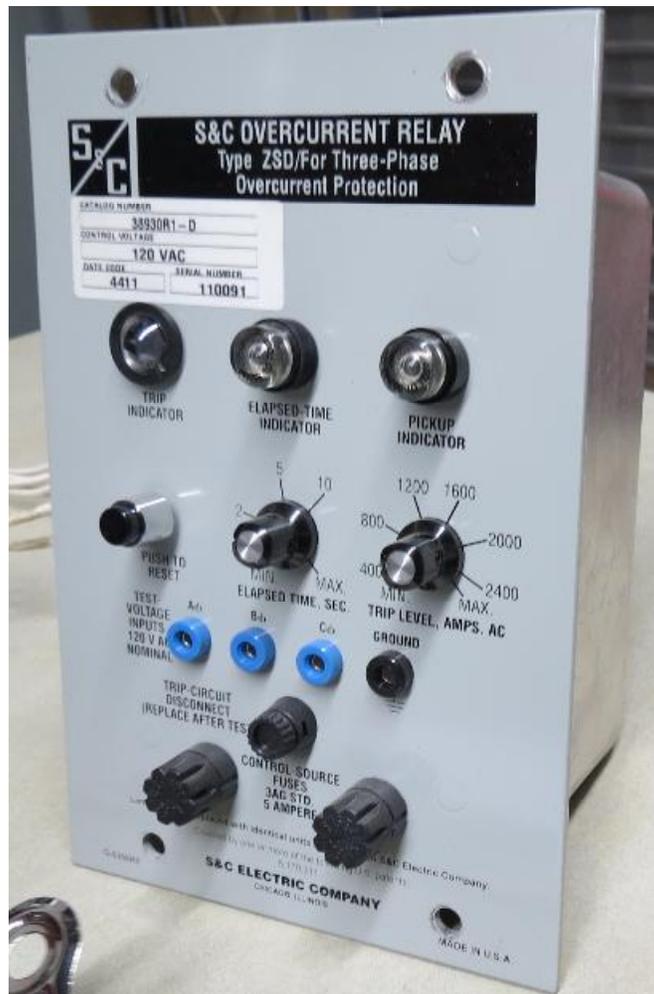
ZSD RELAY. The relays in Bay 7 and Bay 8 were Type ZSD relays, catalog number 38930R1-D, manufactured by S&C Electric Company, supplied with the switchgear lineup installed in 2012 (see Figure 3). The ZSD relay has been in production by S&C since the early 1990s and was recommended to ENOI personnel during the Vault 24 design improvement for the specific application. The description of the relay in the instruction manual is as follows:

consistent operation as the blocking circuit setpoint was substantially different from the trip setting. This instability was observed on all of the relays tested (during testing by this engineer, ENOI, and others in coordination with S&C at Vault 24 on March 1, 2013), including the subject (Bay 8) relay and two identical (exemplar) relays. Behavior of the device in a manner contrary to the published functionality of the device constitutes a design defect.

Based on testing and observations performed after the incident, the subject relay was determined to be set at the time of the incident to approximately 400 A pickup current with a 2 second time delay (later identified as the factory default settings). As the current rose to the pickup setting, the relay armed. After the 2 second time delay, because of the design defect of the relay manifest as an instability as described above, the relay tripped even though none of the phase currents had dropped below 3.5 A, causing the switch to open, initiating the power outage. Tripping of the relay in the absence of any fault or undesirable operating condition constitutes a relay misoperation. Thus a relay misoperation was the cause of the partial power outage.

The misoperation of the relay occurred because the relay had a previously unreported instability in the range of the pickup setting and the pickup setting was in the range of normal operating conditions. Had the relay pickup setting been in excess of the maximum load current anticipated, the misoperation would not have occurred. Thus an inappropriate pickup setting was a contributing factor to the relay misoperation.

Figure 3: Photograph of subject relay from Bay 8 during bench testing after the outage.

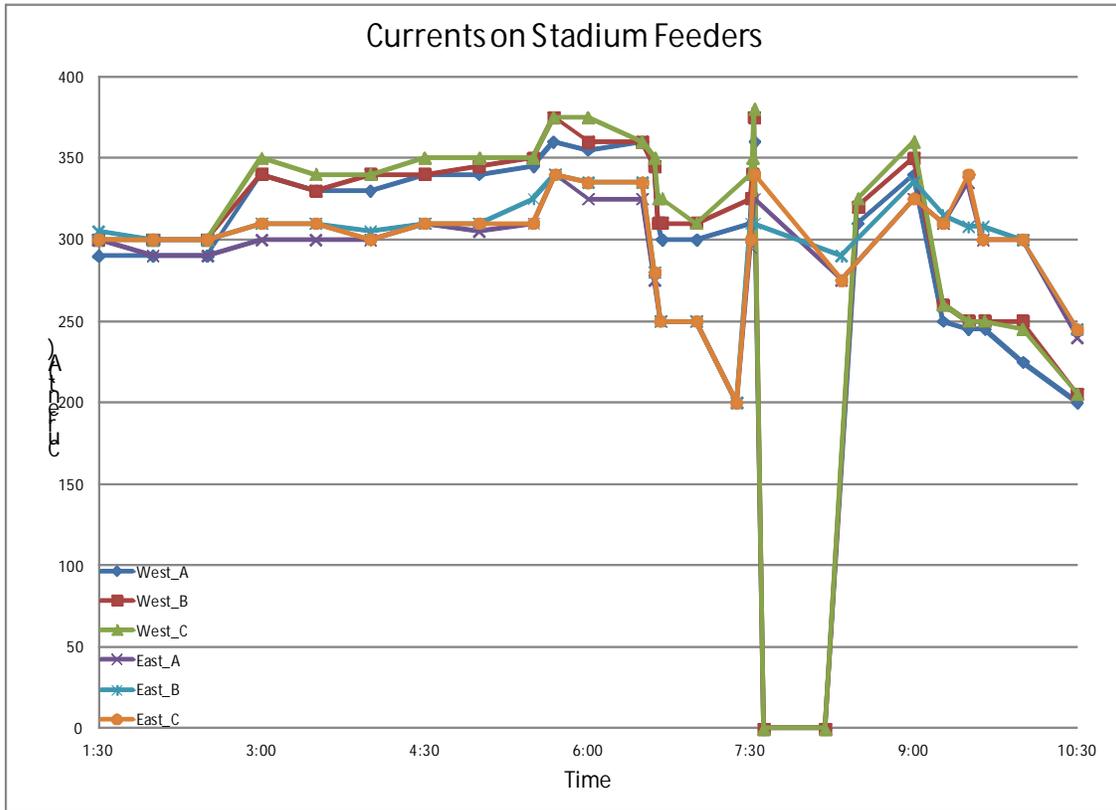
Figure 4: Graph of currents on east and west feeders to Stadium.
